**MITCHELL HISTORIC PRESERVATION COMMISSION AGENDA
CARNEGIE RESOURCE CENTER, 119 W. 3RD AVE, MITCHELL, SD
DATE: AUGUST 29, 2018 TIME: 5:15 PM**

CITY OF MITCHELL
ORDER TO CORRECT

301 NORTH MAIN – BUILDING ASSESSMENT

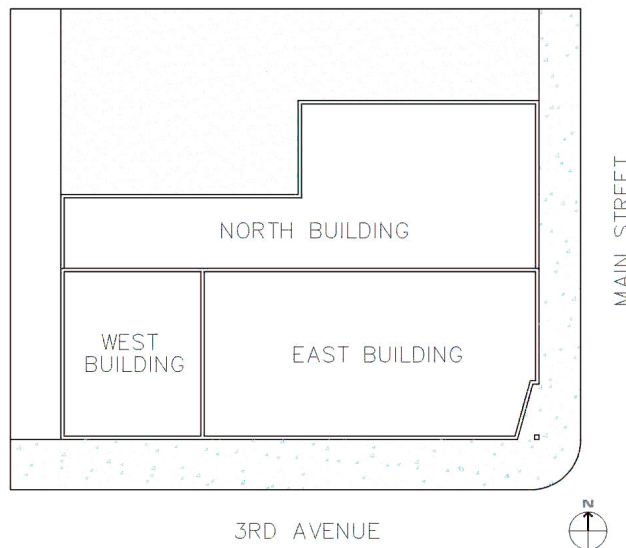
Figure 1. Plan showing building names and locations.

For the purpose of this report, the buildings on the site will be referred to as the East Building, West Building, and North building as shown in Figure 1. The East building is located at 301 Main Street. It should be noted that no original construction drawings for the building under review nor for any of the surrounding buildings were available. Since the primary focus of this review is the large opening in the South wall of the East building, the following will only provide very brief descriptions of the framing systems observed in each building as well as very brief comments on conditions observed.

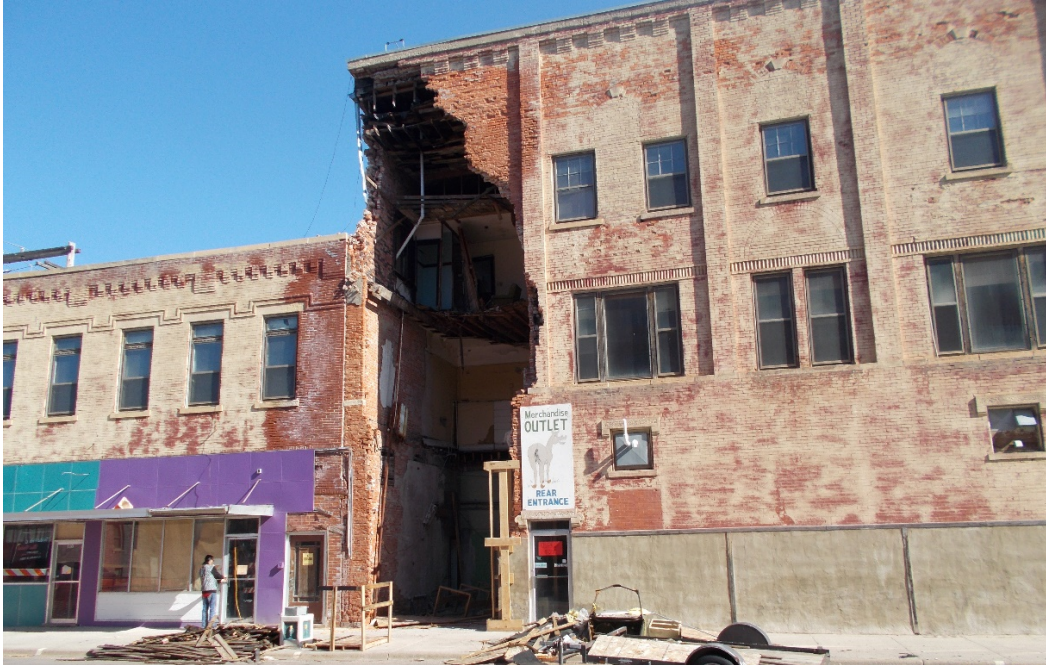
- What began as deterioration in the mortar of the South wall grew to become a hole in the multi-wythe load bearing brick wall.
- The owner attempted to take action by demolishing a portion of the wall. The City put a halt to the project due to safety concerns.
- Currently, an approximate 15'-0" wide opening in the South wall extends from the main level floor to a few feet below the roof framing leaving the roof framing and a portion of the masonry wall unsupported.
- Debris from the hole in the building has led city official to close the sidewalk and street to the South of the building.

Figure 2. Photo showing condition of South wall on April 27, 2018

1. Remove 17'-0" of the West end of the East building. See Appendix for drawings showing recommendations described below.
 - a. Since the West wall of the East building is bearing for the floor and roof of the West building, the West wall of the East building will need to be sawcut above the roof of the West building and removed from the sawcut to the top of the wall.

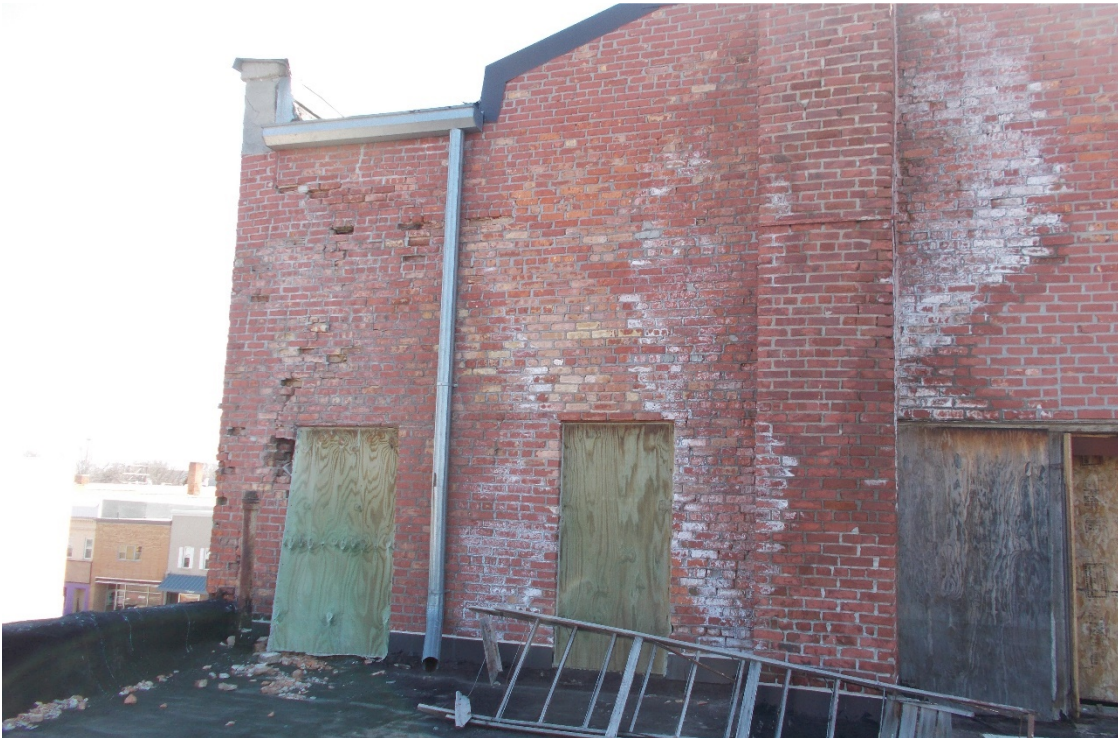
- In several locations, the exterior wall was observed to be in poor condition. Damaged or broken windows and lack of maintenance has allowed water to cause the mortar to deteriorate over time. A photo of the large opening in the South exterior wall is provided in Figure 2. A photo of the severely deteriorated west wall is shown in Figure 3. Figure 4 shows the condition of the masonry wall in the Northwest corner of the East building.

Figure 3. Photo showing deteriorated masonry along West wall of East building.

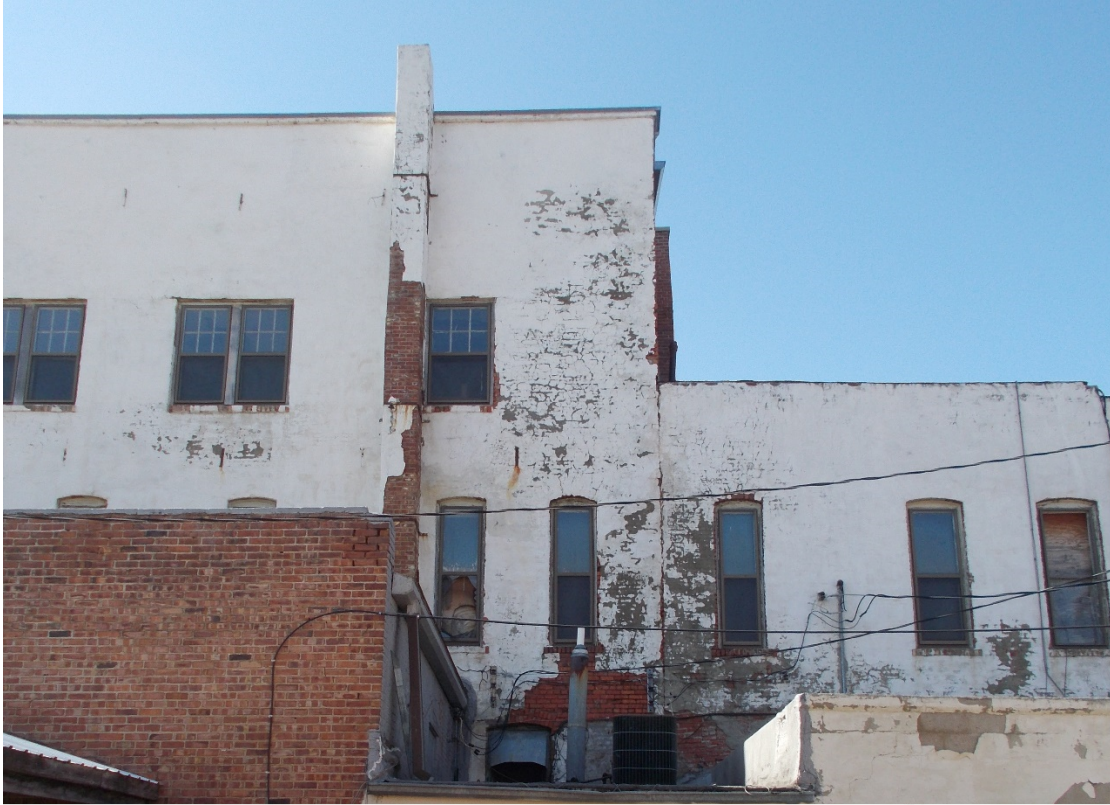
Figure 4. Photo of Northwest corner of East building.
